Manhole Inspection Summary

Manhole # S25M__027MH

Insp Date: **3/3/08 10:02 AM**

Location Address: **S.CAREY ST.**

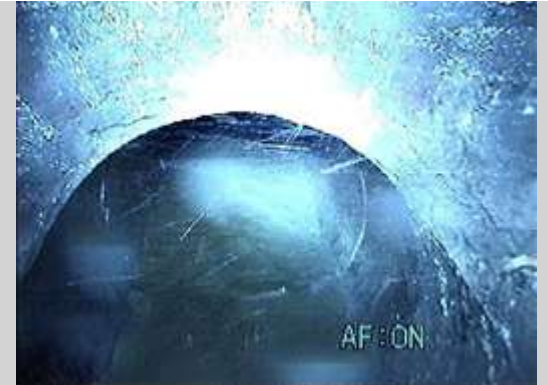
12 O'Clock Outflow

21 in. Circular Gravity Sewer
Pipe Out @ 12 O'Clock

Pipe Height: **22.8** (in.) Rod and Bar (Angled)
Pipe Material: **Clay** ☐ Pipe Lined
Invert Depth: **15.40** (ft.) Flow Characteristics: **Slow**
Deposits: ☒ None ☐ Mud ☐ Sludge ☐ Debris ☐ Grease
Silt Depth: **0** (in.) Deposits Extent:
Infiltration: **None** Pipe Seal Cond: **Sound**

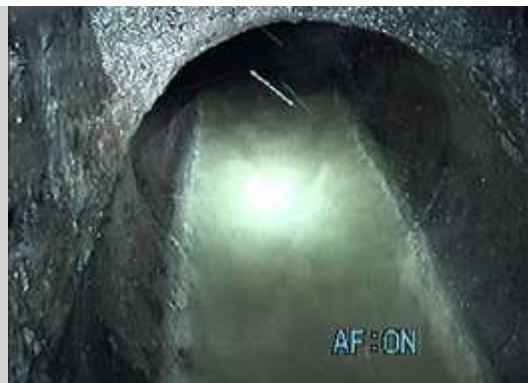
6 O'Clock Inflow

21 in. Circular Gravity Sewer
Pipe In @ 6 O'Clock

Pipe Height: **19.2** (in.) Rod and Bar (Angled)

Infiltration: **None** Pipe Seal Cond: **Sound**
